NASA TECHNICAL NOTE

NASA TN D-2040

A STUDY OF SEVERAL
OXIDATION-RESISTANT COATINGS
ON Mo-0.5Ti ALLOY SHEET AT 2,500° F

by *Donald R. Rummler, Bland A. Stein,*
and Richard A. Pride

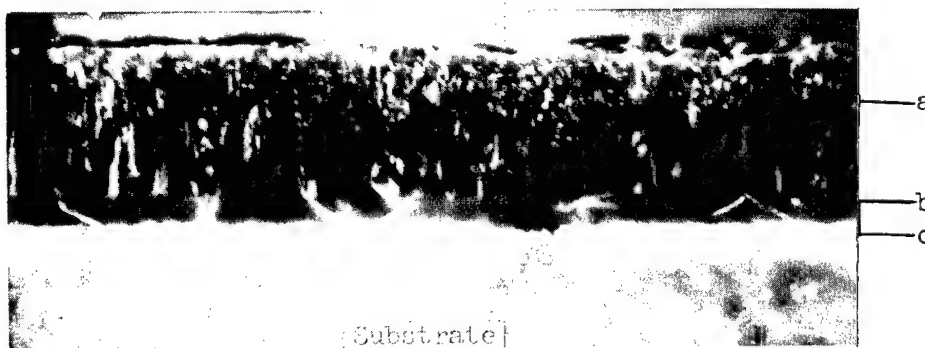
Figure 4.- As-coated coating A(G) tumbled-edge oxidation specimen. L-63-4790

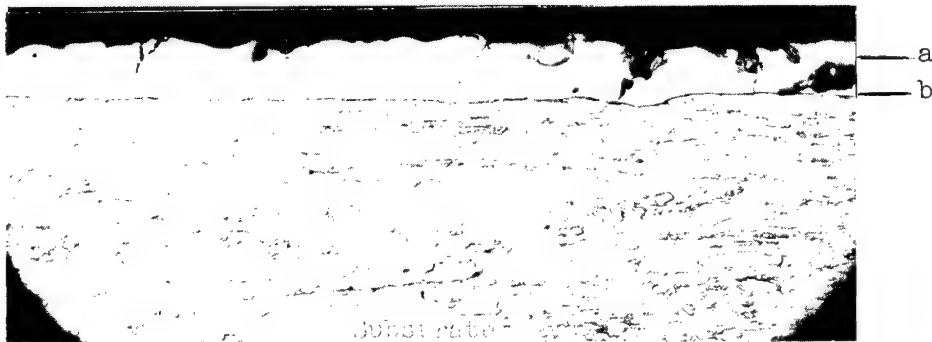
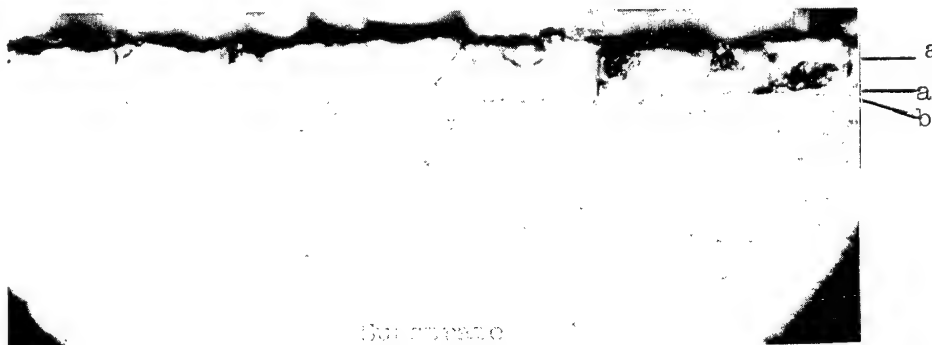
Figure 6.- As-coated coating C broken-edge oxidation specimen.

Coating C: [The typical as-coated appearance of coating C (fig. 6(a)), although a highly modified disilicide coating, was characteristically dull gray with a matte texture. Some unevenness of color was noted near the edges but none of the specimens had the mottled appearance of other modified coatings.] When examined under bright light, a cross-sectioned specimen (fig. 6(b)) appeared to contain only two phases (a and b). However, when examined under polarized light (fig. 6(c)), the outer phase (a) contained two distinct grain structures (a and a'). Although both are columnar in form, the grain structure on the outer surface (a) consisted of larger grains which were less severely oriented than the inner grain structure (a'). Although it is not clearly apparent in the photomicrograph, the appearance of these two grain structures under polarized light differs considerably from that of the other coatings. In all the other coatings, the phase which was optically active under polarized light (assumed to be MoSi_2) appeared to be composed of varying shades of bluish gray. In coating C this phase was made up of various shades of pink and light gray. This coloring may be due to the $\text{Mo}(\text{Al},\text{Si})_2$ which was identified on the surface of the coating by X-ray diffraction. Although different in appearance, the two grain structures (a and a') exhibited the same Knoop hardness (ref. 6). There was also a thin phase (b) next to the molybdenum substrate which was not active under polarized light and revealed no grain structure with the etchant used. Coating C was the thinnest and most nonuniform of the coatings investigated.

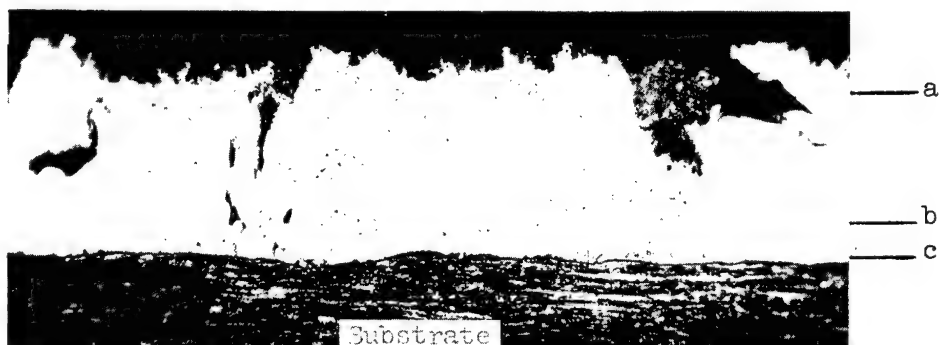
Figure 8.- As-coated coating E broken-edge oxidation specimen. L-63-4794

Coating E: (Coating E was mottled gray in color and exhibited the roughest surface texture of the coatings supplied) (fig. 8(a)). All the broken-edge and sheared-edge specimens which were provided to the supplier for coating applications received additional edge treatment. The edges and corners were rounded abrasively and, as a result, oxidation data presented for the coated broken-edge and sheared-edge specimens are of questionable value for comparing the effects of the different edge conditions. When this coating was cross sectioned and examined under bright light (fig. 8(b)), it was found to contain three distinct phases. The dark outer layer (a) appeared to be dense and showed no grain structure. When examined under polarized light (fig. 8(c)), it was apparent that the outer phase (a) was not just a porous form of the MoSi_2 . The second phase (b) exhibited the columnar, optically active, structure of MoSi_2 when deposited by pack cementation.

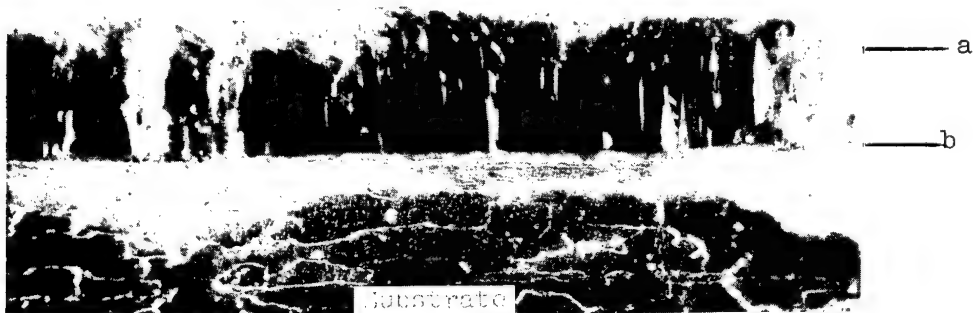
Figure 9.- As-coated coating F sheared-edge oxidation specimen. L-63-4795

Coating F: (As was noted for coating E, coating F broken-edge and sheared-edge specimens were given additional edge treatment prior to coating by the coating supplier. The coating surface was mottled dull gray with a matte texture) (fig. 9(a)). Coating F under bright light and in cross section (fig. 9(b)) was uniform in thickness. The etchant used revealed a two-phase system similar to the other two-phase coatings. Under polarized light (fig. 9(c)), the optically active MoSi_2 made up the major portion of the coating (a). A thin phase (b) which is assumed to be Mo_5Si_3 separated the MoSi_2 from the substrate. This thin phase, as in the other coatings, showed no grain structure. Xr 10

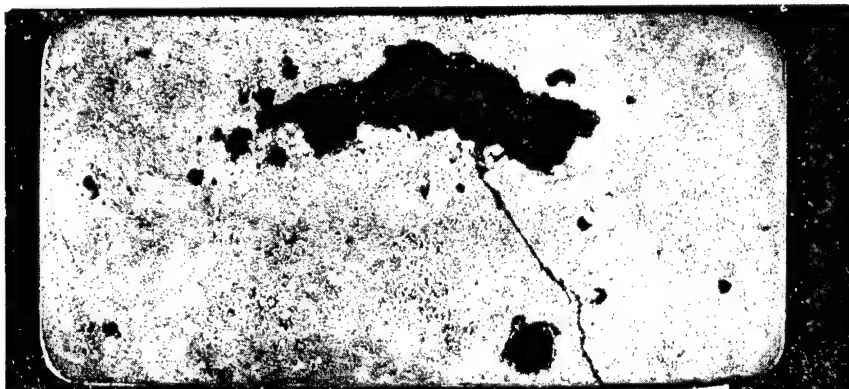
Figure 18.- Coating E broken-edge oxidation specimen after 0.1 hour of continuous exposure at 2,500° F in air. L-63-7501

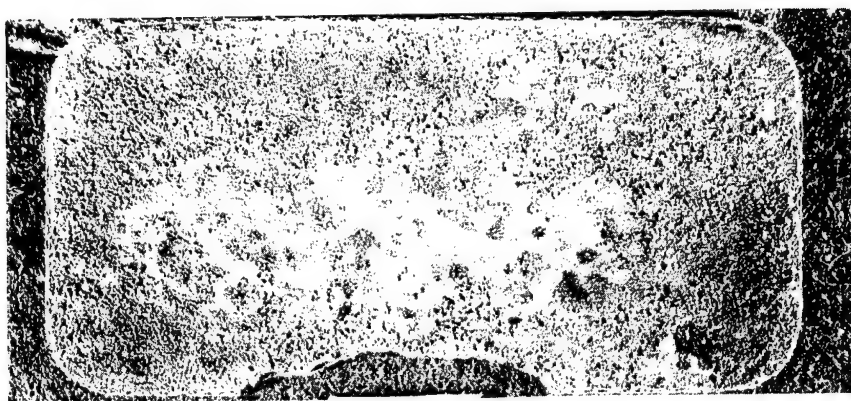
Figure 29.- Coating E tumbled-edge oxidation specimen after forty-four 0.1-hour cycles at 2,500° F in air.

The cyclic tests provided a good opportunity to observe the initiation of failure, and as previously mentioned, visual examination was an unreliable method of detection. After each cycle the specimens were inspected, and in some cases a weight loss of 3 percent did not produce a visible defect in the coating. When a visible defect was found, the specimen was probed to reveal the full extent of substrate damage. Some typical examples of these initial defect points are presented in figures 26(a), 27(a), and 28(a). Figures 26(b), 27(b), and 28(b) present these same specimens after failure. In figure 28 the final failure appears to be only an extension of the original defect. The continued oxidation of the initial defect to produce a 10-percent weight loss was not the only mode of failure. In most of the cycled specimens, other points of failure on the edges were initiated before a 10-percent weight loss terminated the test (figs. 26 and 27). These additional edge failures indicated that the edges of the cycled specimens were marginally protected by the coating when the specimens were subjected to thermal cycling. When the test was terminated, the full extent of substrate damage was not apparent until after the specimens were probed to remove unsound material. Figures 29, 30, and 31 show typical failed specimens before and after probing.

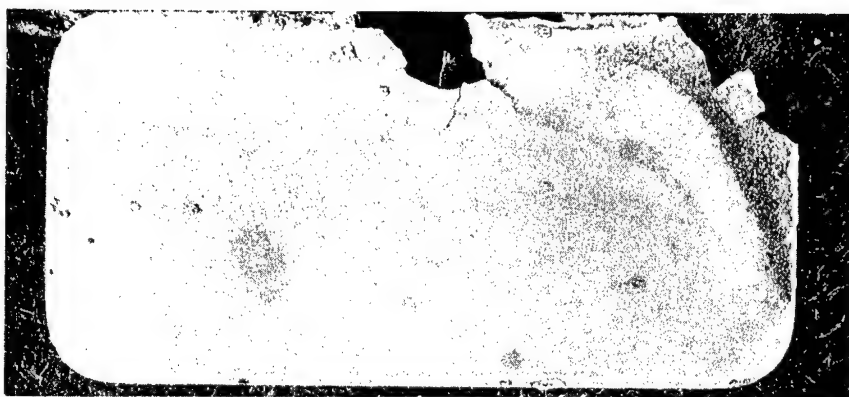
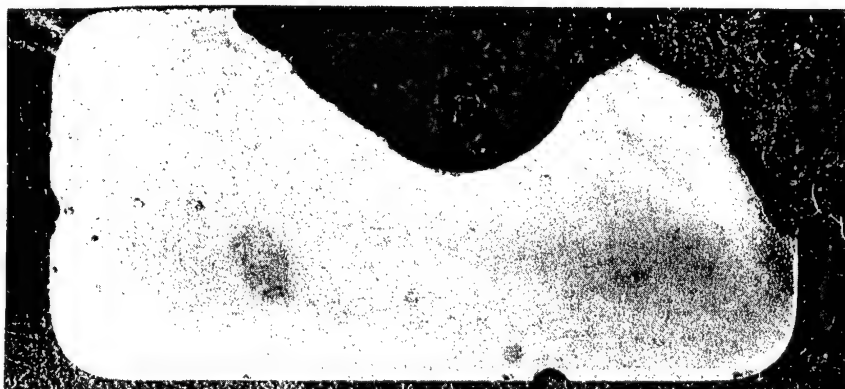
Figure 30.- Coating C tumbled-edge oxidation specimen after three 1.0-hour cycles at 2,500° F in air.
